THE RUINS MIXED-USE DEVELOPMENT

Watertown, SD

CONSTRUCTION OBSERVATION REPORT

Project No. 24-020

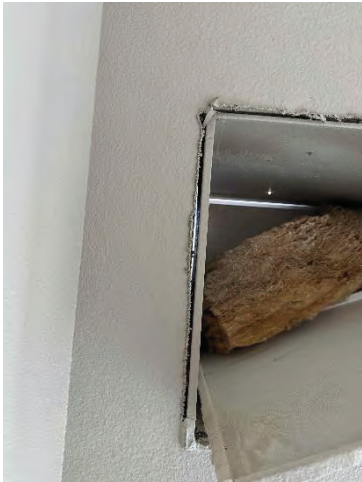
- No observed spray foam or seal at all AC sleeve penetrations.
- No observed foam seal at any exterior louvers

Missing Insulation at AC Sleeve

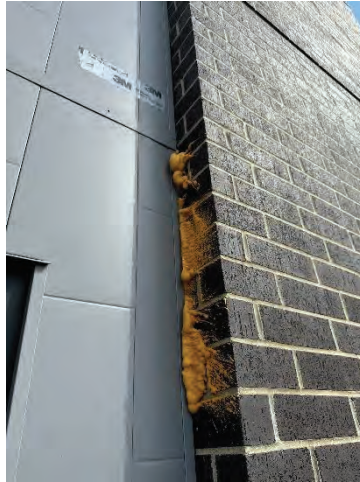
- Overspray of spray foam observed at the transition from the brick stair to the metal siding at various locations.

Spray Foam Overspray

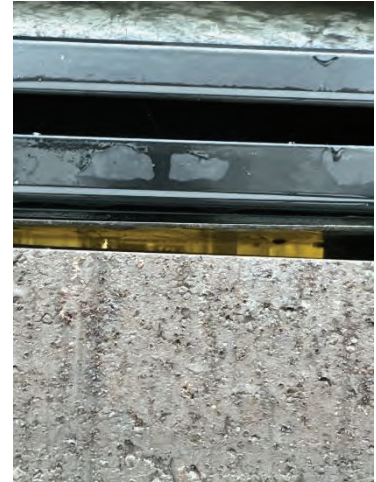
Exterior Louver

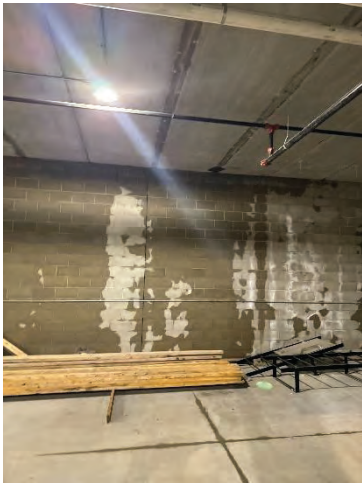
- The spray-applied weather barrier at the edges of the precast planks at 2nd floor was not properly completed. As a result, significant moisture penetration along the CMU walls was observed at the time of the inspection.
- None of the CMU control joints were caulked or sealed prior to the spray-applied weather barrier.
- In our opinion, there is concern with the transition of the Tyvek weather barrier to the CMU block at the stair towers.

Moisture Observed on North wall, 1st Floor.

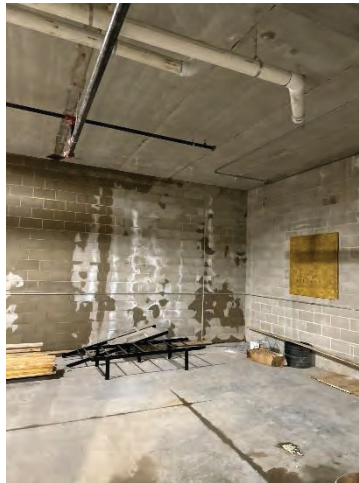
Moisture Observed on North wall, 1st Floor.

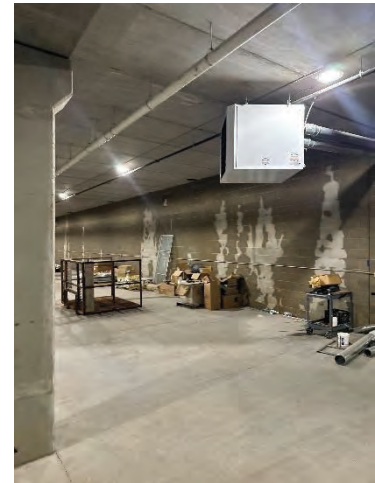
Moisture Observed on North wall, 1st Floor.

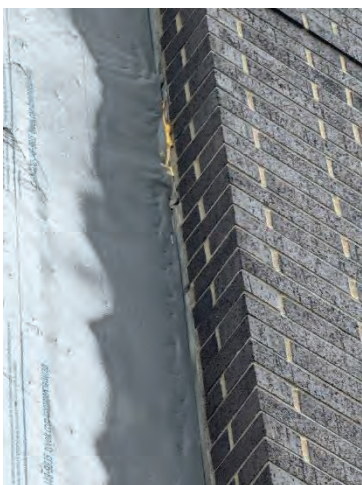
Tyvek to Spray Applied Transition

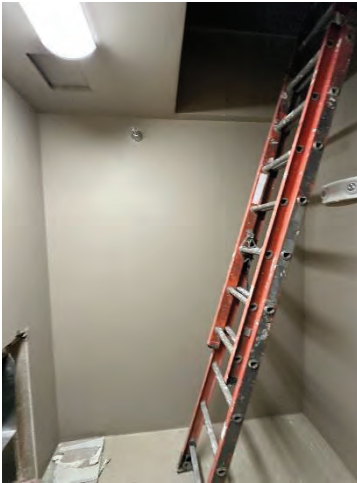
4th Floor Roof Access Ladder
not Installed.

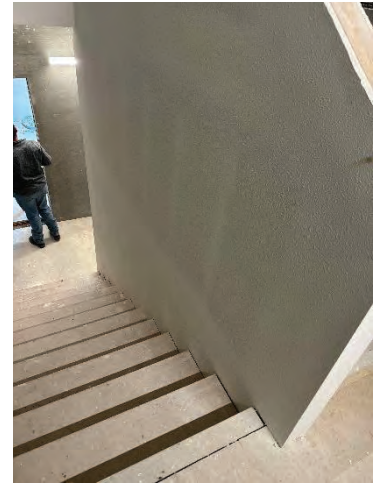
Handrail Missing, West Stair
Tower

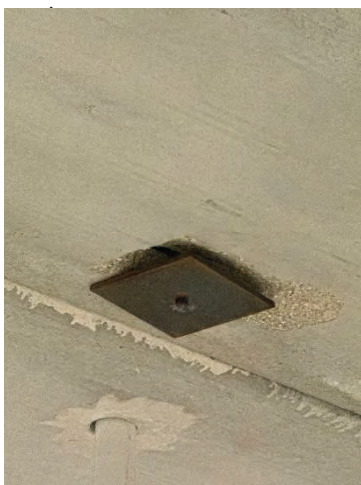
- o Observed various hold down plates not tight to underside of precast.
- o In our opinion, the Tyvek Building Wrap has deteriorated from the time of installation to the time of the inspection. Manufacturer inspection required to determine if current Tyvek building wrap is acceptable for warranty.

Loose Hold down Plate

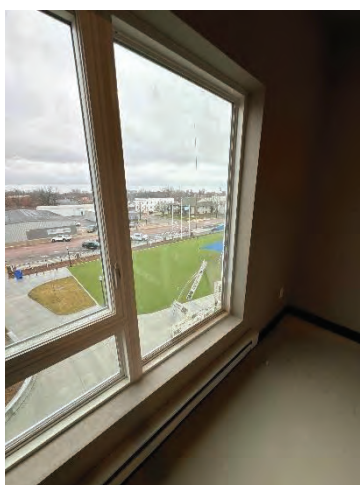
- o Observed approx. 10-15 windows with either broken or missing glass.
- o Observed approx. 12-17 windows with broken or malfunctioning latches and/or cranks.

Broken Window Pane

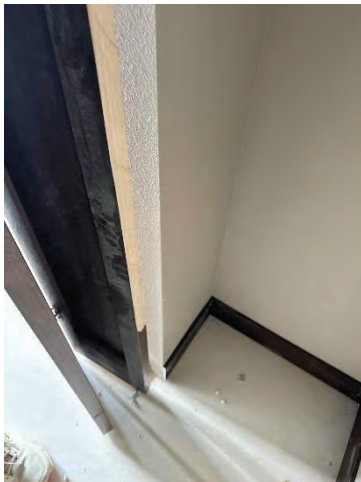
- Observed several damaged unit entry doors.
- Observed numerous units which had the back of the closet bi-fold doors ripped down to fit the opening.
- Observed wood base installed prior to unit flooring and no gap between the subsurface and the bottom of the base.
- Observed no trim/casing around the AC cans. We are unsure how this finish condition should be, but it is an area of potential additional work required.

Back side of Bi-Fold Doors
Ripped Down to fit opening.

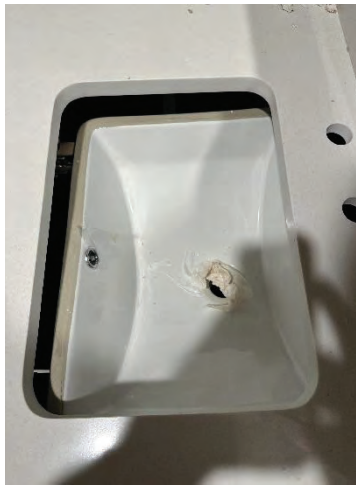
4th Floor Unit, Damaged Sink

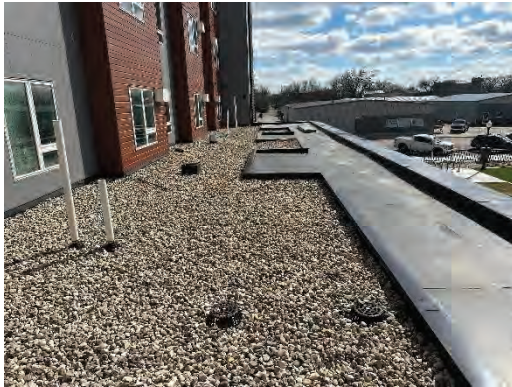
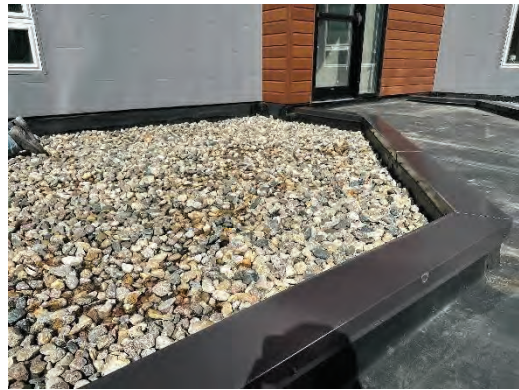
- Excess materials and dunnage located on the roof to be removed.
- Observed several locations of soft spots in the roofing surface, possibly due to gaps in the coverboard.
- Observed several locations of cuts and damage to the low roof on the west side of the building.
- Observed areas of roof that were not draining properly and was holding approx. 1" of water.

Observed standing water in this location

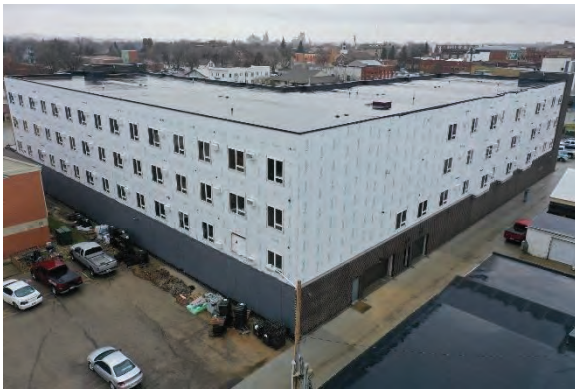
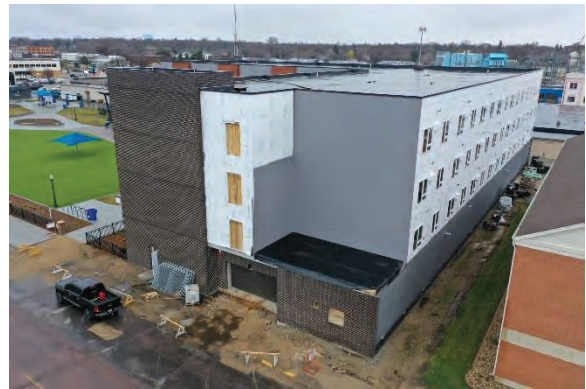
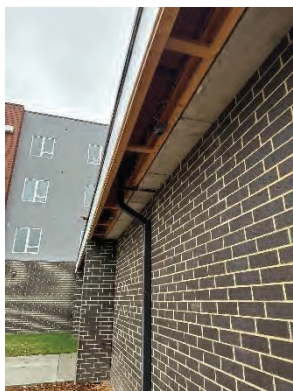
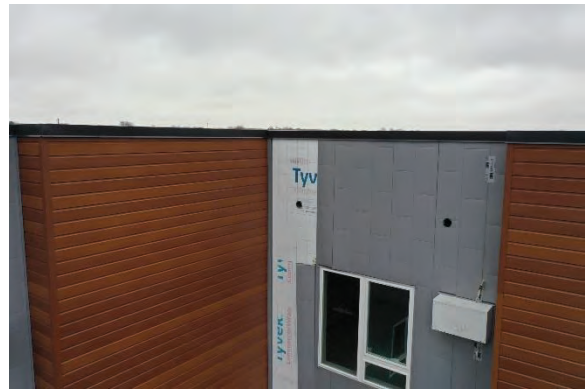
- Observed numerous areas where 3M flashing tape was applied to the face of the metal panels. The reasoning for the application of the tape was unable to be determined.
- Observed panels that were falling off or removed from the building at the interior corner of the west elevation of the building.

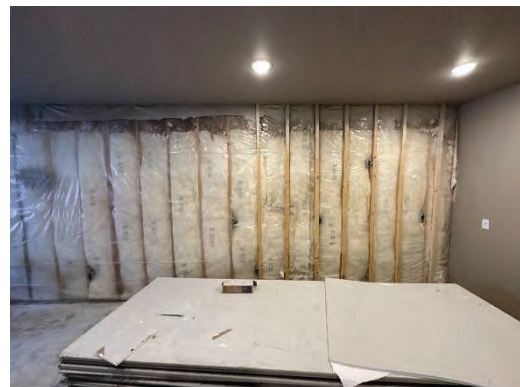
2nd Floor Unit

- 1st Floor:
 - All elevator openings need to be completed.
- 2nd Floor: 75% Complete
 - Observed 2 units where drywall needed to be completed throughout the unit.

- Observed 1 unit with significant touch ups and repair required.
 - Observed several locations where drywall repair due to other trade activities required.

- Observed several locations where drywall repair due to water damage is required (see Section GENERAL W&L ROUGH CARPENTRY LABOR for more detail).
- 3rd Floor: 80% Complete

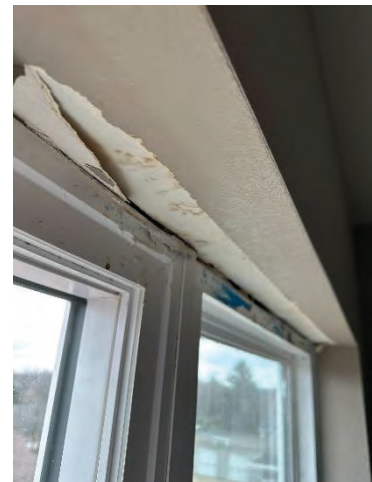
4th Floor Unit, Several Locations

- Observed several locations where drywall repair due to other trade activities required.
 - Observed several locations where drywall repair due to water damage is required (see Section GENERAL W&L ROUGH CARPENTRY LABOR for more detail).

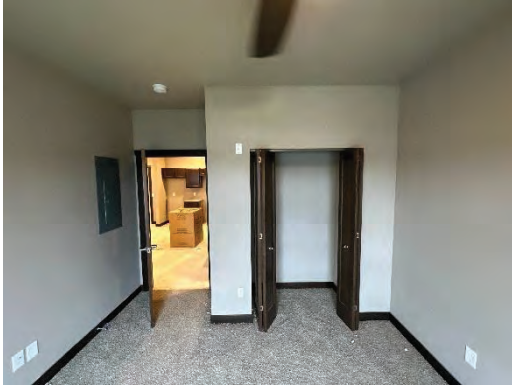
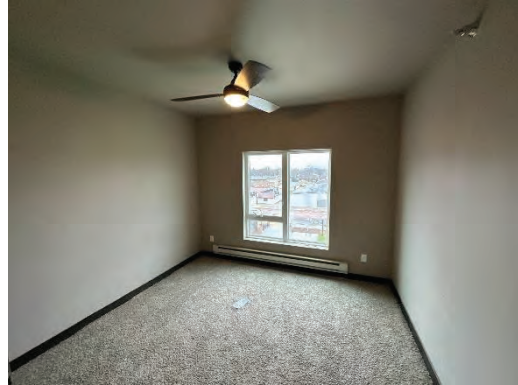
- 2nd Floor: 0% Complete
 - Observed no units with any carpeting installed or stocked within the unit.
- 3rd Floor: 0% Complete
 - Observed no units with any carpeting installed or stocked within the unit.
- 4th Floor: 80% Complete
 - Observed 2 units without any carpeting installed or stocked within the unit.

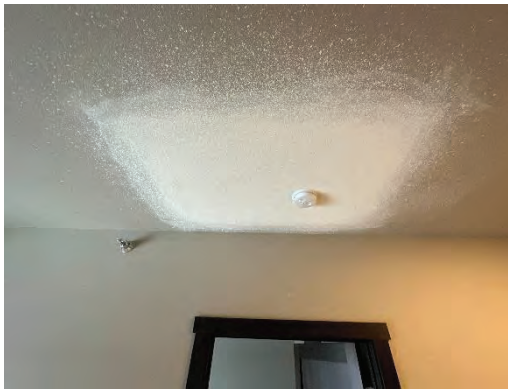
- 1st Floor: 0% Complete
 - The public restroom area needs to be completed.
 - Stair towers need to be completed.
- 2nd Floor: 90% Complete
 - Observed 2 units that needed significant painting completed.
 - Most of the units require only small touch ups to complete.
- 3rd Floor: 90% Complete
 - Observed 1 unit that needed significant painting completed.
 - Most of the units require only small touch ups to complete.
- 4th Floor: 80% Complete
 - Most of the units require only small touch ups to complete.
 - Lobby and elevator openings need to be completed.

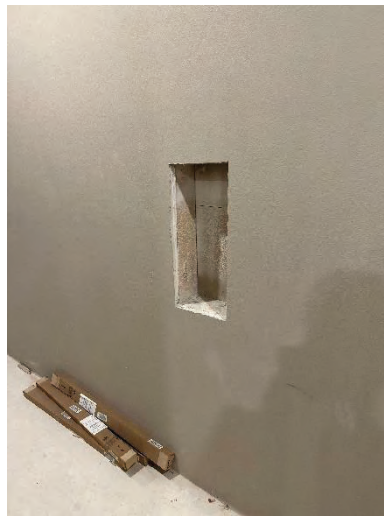
3rd Floor Lobby

- Observed floor to accessibility height of fire extinguishers to be higher than typical. This will need to be reviewed with the local building official to determine if the height will need to be adjusted.
- Observed fire extinguisher cabinet openings to be absent of sheetrock on the inside of the opening. If standard fire extinguisher cabinets are used, this may need to be sheet rocked to maintain corridor fire rating. Alternatively, fire rated cabinets may be able to be used. Review with local building officials necessary to confirm.

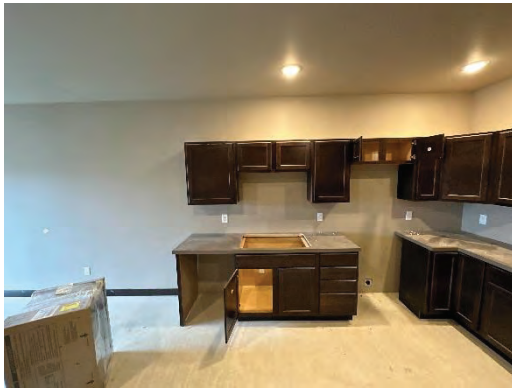
- 2nd Floor: 5% Complete
 - Observed one 1 unit with the sink set in place in the kitchen.
 - Observed all units without the sinks hooked up.
- 3rd Floor: 0% Complete
 - Observed all units without the sinks stocked or hooked up.
- 4th Floor: 0% Complete
 - Observed all units without the sinks stocked or hooked up.

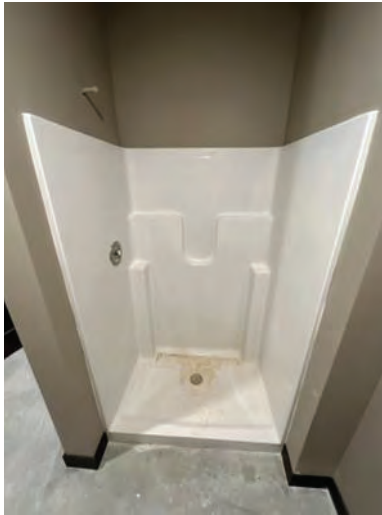
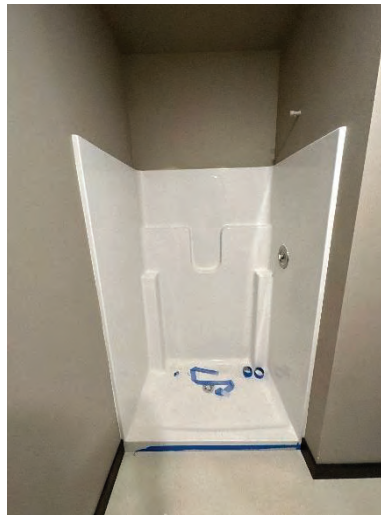
- 2nd Floor: 0% Complete
 - Observed all units where plumbing faucets and shower heads were not installed.
- 3rd Floor: 0% Complete
 - Observed all units where plumbing faucets and shower heads were not installed.
- 4th Floor: 0% Complete
 - Observed all units where plumbing faucets and shower heads were not installed.

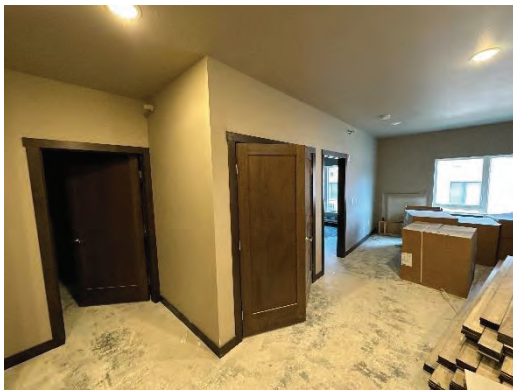
- 1st Floor: 90% Complete
 - Main piping and distribution completed.
 - Riser pipe and valves installed and wired.
 - Final inspection tags not completed.
- 2nd Floor: 90% Completed with trim out.
 - Observed majority of sprinkler heads trimmed out in the units, a few that were incomplete.
- 3rd Floor: 90% Completed with trim out.
 - Observed majority of sprinkler heads trimmed out in the units, a few that were incomplete.
- 4th Floor: 90% Completed with trim out.
 - Observed majority of sprinkler heads trimmed out in the units, a few that were incomplete.

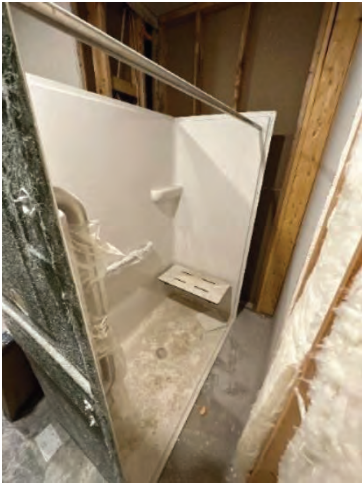
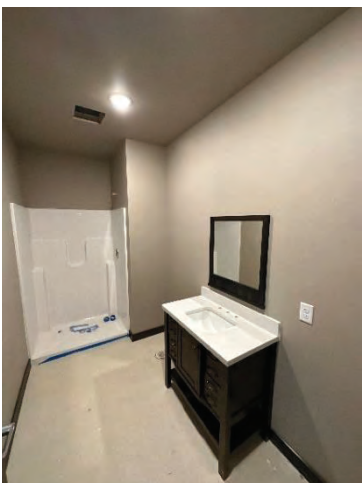
- 1st Floor: 5% Complete
 - All PVC needs to be tied in and hooked up to building sanitary.
 - No fire collars have been installed.
 - Plumbing rough in and fixtures need to be completed in the 1st floor common bathroom area.
- 2nd Floor: 60% Complete
 - Observed 2 units where showers were not installed. They were stocked in units.
 - None of the toilets have been installed.
 - No water to any unit, all rough-in is assumed to be completed and inspected.
- 3rd Floor: 75% Complete
 - None of the toilets have been installed.
 - No water to any unit, all rough-in is assumed to be completed and inspected.
- 4th Floor: 75% Complete
 - None of the toilets have been installed.
 - No water to any unit, all rough-in is assumed to be completed and inspected.

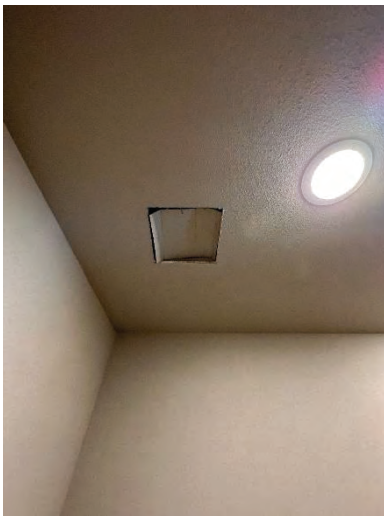
- 1st Floor: 60% Complete
 - Sealant at all exterior louvers needs to be completed.
 - Bathroom HVAC needs to be completed.
- 2nd Floor: 90% Complete
 - Observed all units to be missing the bath fan trim cover.
- 3rd Floor: 90% Complete
 - Observed all units to be missing the bath fan trim cover.
- 4th Floor: 90% Complete
 - Observed all units to be missing the bath fan trim cover.

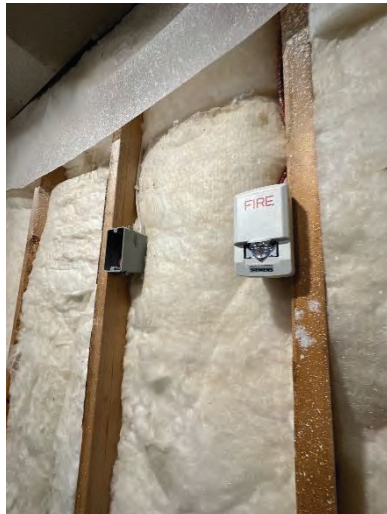
2nd Floor Unit

- 1st Floor: 90% Complete
 - Observed potential concern with shaft rating for electrical feeder wire.
 - Observed potential concern with clearance and proximity to fire sprinkler piping.
- 2nd Floor: 90% Complete
 - Observed majority electrical devices installed throughout the floor, regardless of finishes.
 - Panels are labeled but did not have final sign off stamp.
- 3rd Floor: 90% Complete
 - Observed majority electrical devices installed throughout the floor, regardless of finishes.
 - Panels are labeled but did not have final sign off stamp.
- 4th Floor: 90% Complete
 - Observed majority electrical devices installed throughout the floor, regardless of finishes.
 - Panels are labeled but did not have final sign off stamp.

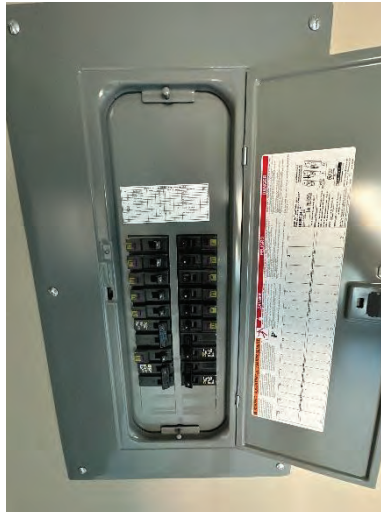
2nd Floor Unit, Typical Condition

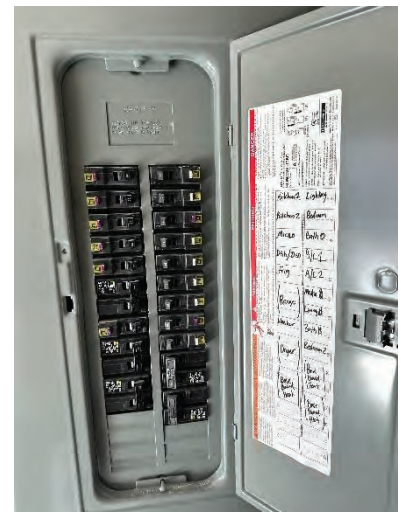
3rd Floor Unit, Typical Condition

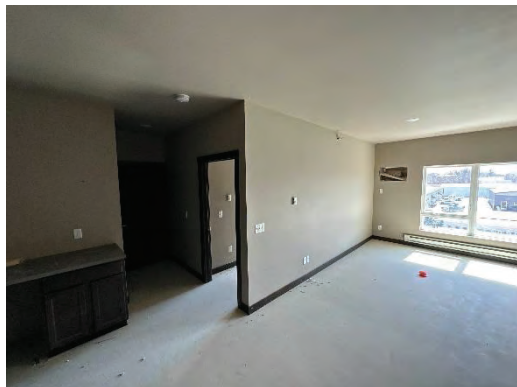
3rd Floor Unit, Typical Condition

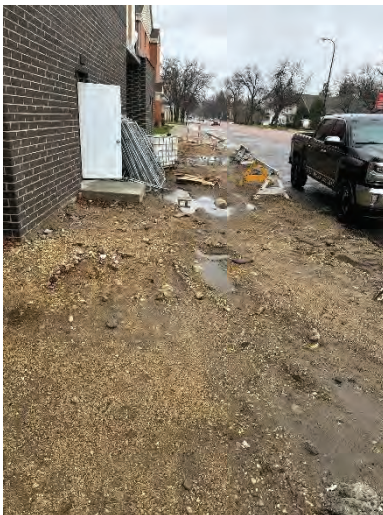
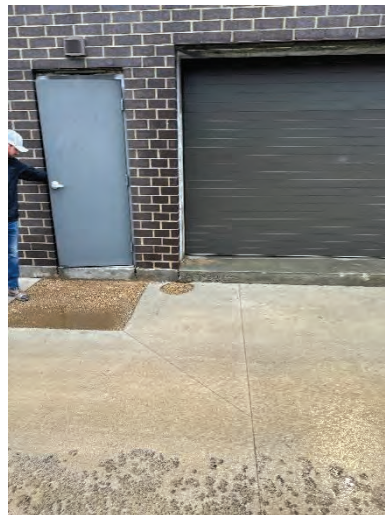
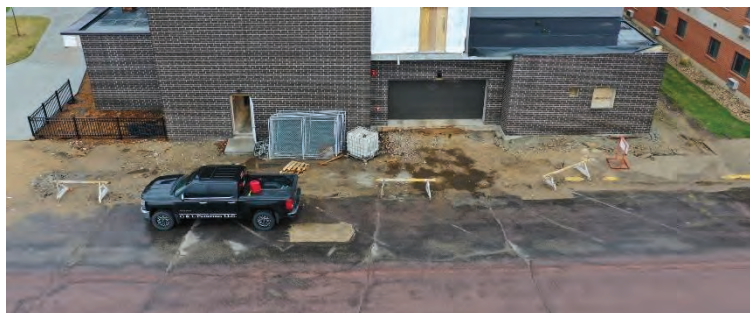
- Did not perform detailed inspection of the pavement for chips, cracks, and damage from construction.
- North Elevation - Elevation of the concrete alley does not match the elevation of the finished floor of the building. Concrete removal and replacement work is necessary to allow for proper transition of grade from building to alley.

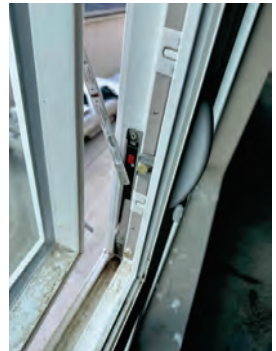
#584: Window latch broken

Type:	Location: 2nd Floor>Fitness Center
Date Created: 04/17/2024	Due Date: 04/20/2024
Priority:	Status: Initiated

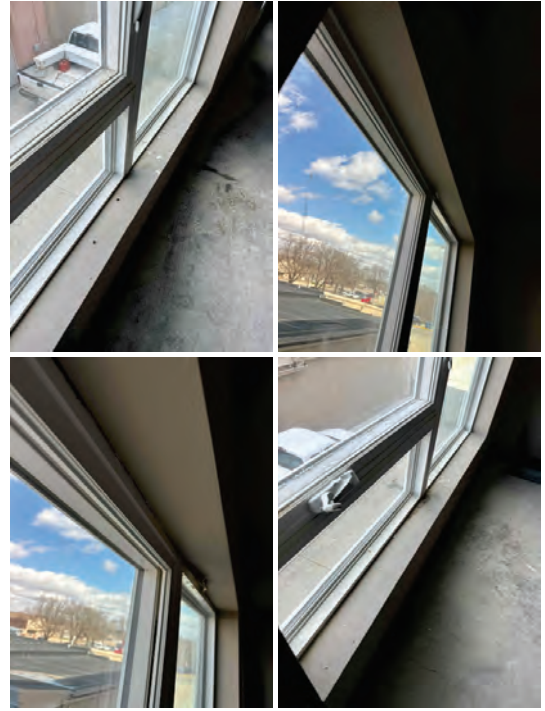
#585: Repair water damaged drywall at windows

Type:	Location: 2nd Floor>Fitness Center
Date Created: 04/17/2024	Due Date: 04/20/2024

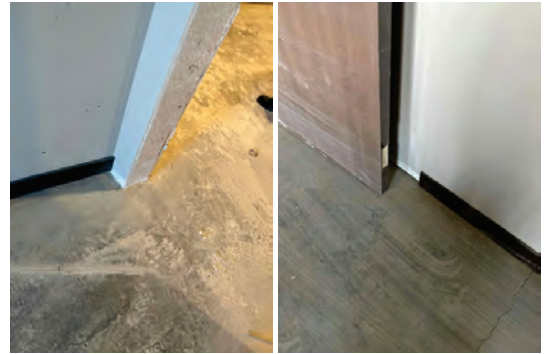
#587: Complete cabinets, countertops, and trim

Type:	Location: 2nd Floor>Fitness Center
Date Created: 04/17/2024	Due Date: 04/20/2024
Priority:	Status: Initiated

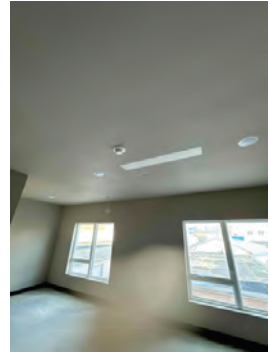
#588: Paint touch up

Fix once drywall is patched

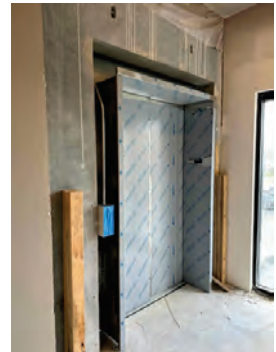
#691: Masonry infill at elevator door

Type:	Location: 2nd Floor Hallway
Date Created: 04/17/2024	Due Date: 04/20/2024
Priority:	Status: Initiated

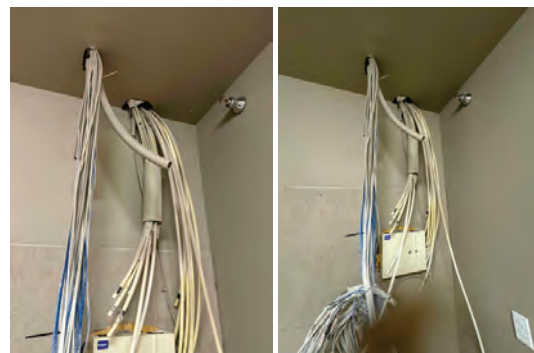
#589: Electrical incomplete

Type:	Location: 2nd Floor>Mech/Jan't
Date Created: 04/17/2024	Due Date: 04/20/2024
Priority:	Status: Initiated

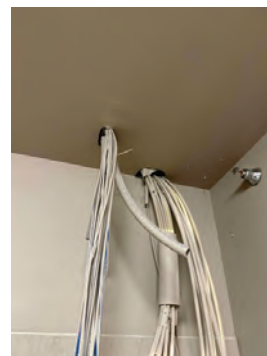
#590: Fire stopping missing

Type:	Location: 2nd Floor>Mech/Jan't
Date Created: 04/17/2024	Due Date: 04/20/2024
Priority:	Status: Initiated

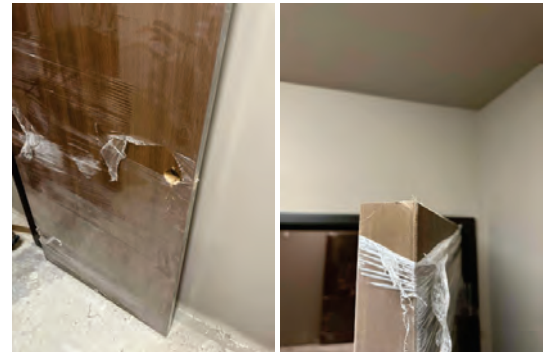
#577: Complete door hardware

Type:	Location: 2nd Floor>Trash Chute
Date Created: 04/17/2024	Due Date: 04/20/2024
Priority:	Status: Initiated

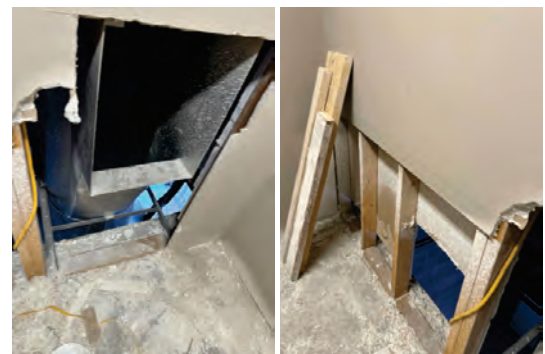
#578: Drywall patch

Type:	Location: 2nd Floor>Trash Chute
Date Created: 04/17/2024	Due Date: 04/20/2024
Priority:	Status: Initiated

Wall for trash chute doesn't meet 2-hour rating

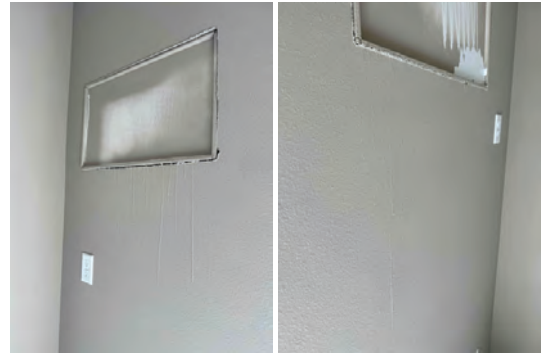
#473: Shelving Missing

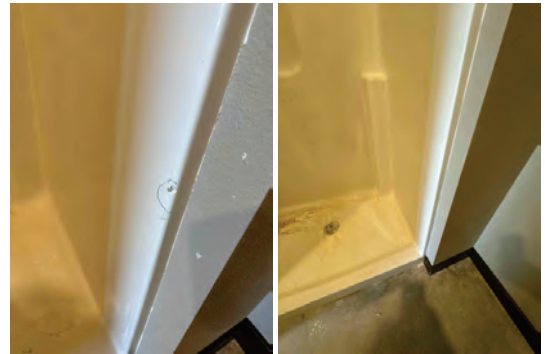
#478: Chipped shower surround

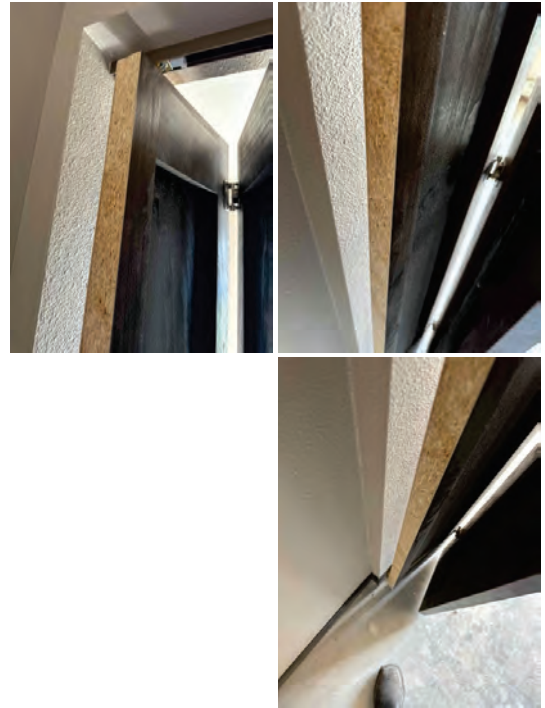
#481: Complete door hardware

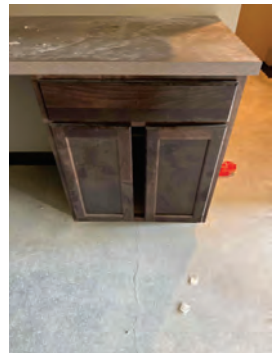
#482: Complete cabinets, countertops, and trim

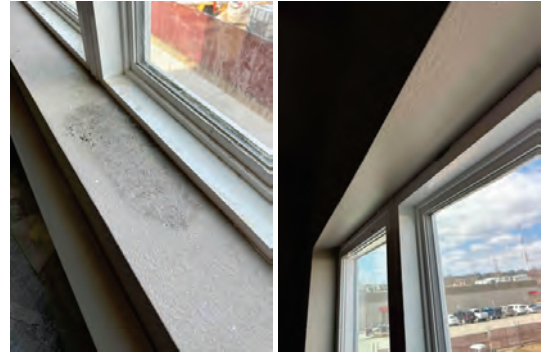
**#512: Repair water damaged drywall at bedroom window**

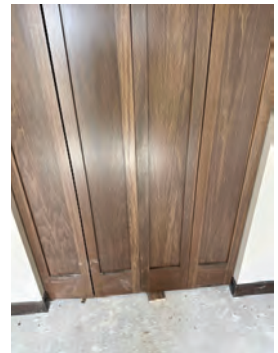
#503: Complete door hardware

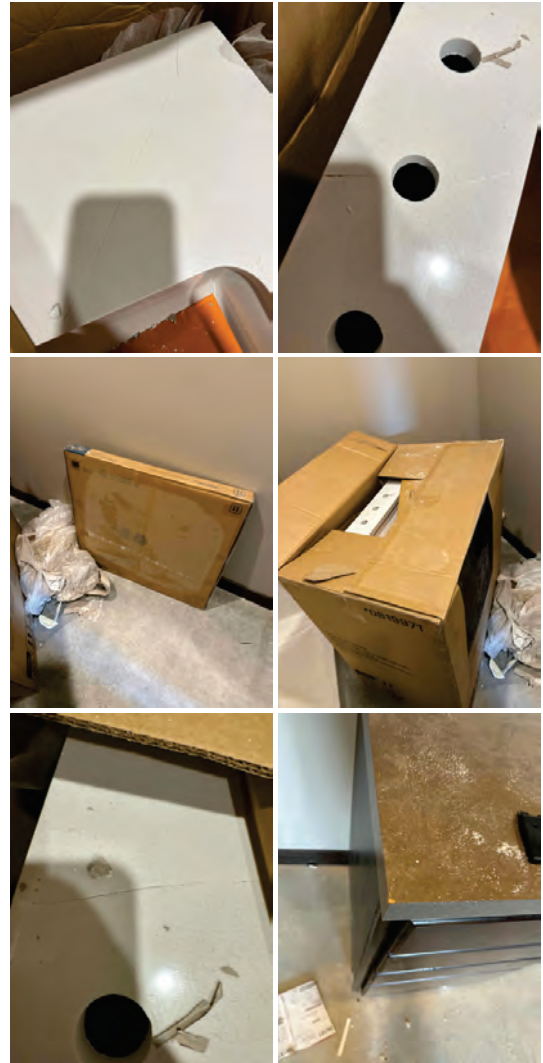
#504: Complete cabinets, countertops, and trim

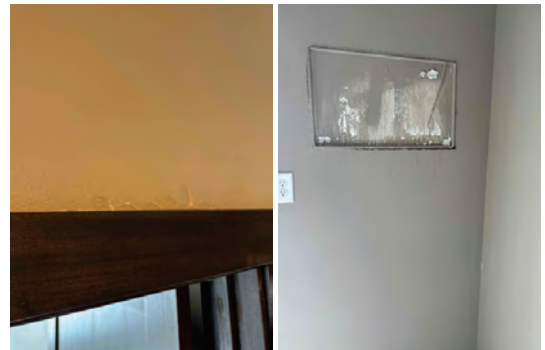
#508: Drywall patch

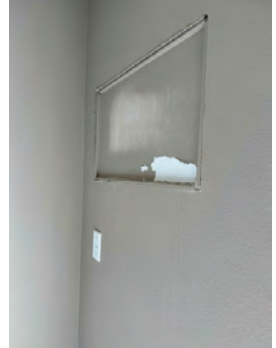
#518: Paint touch up

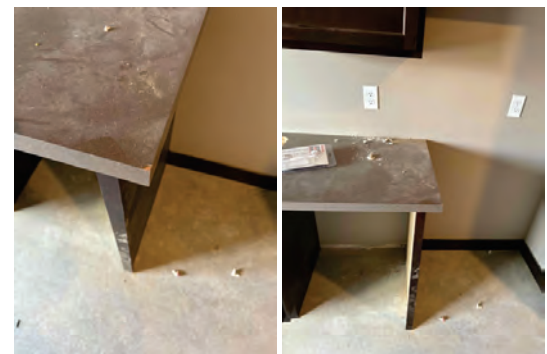
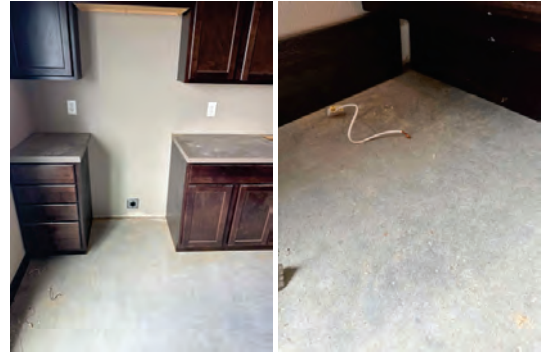
#497: Complete cabinets, countertops, and trim

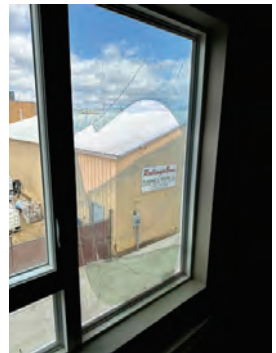
#511: Window pane broken in bedroom

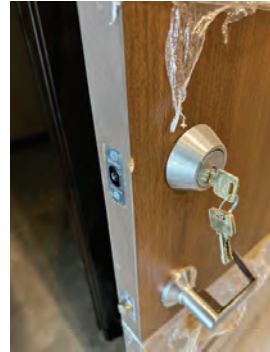
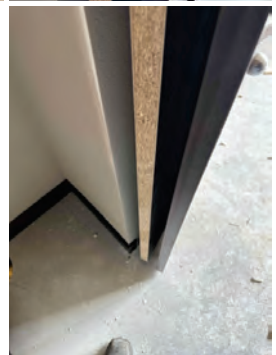
#541: Complete door hardware

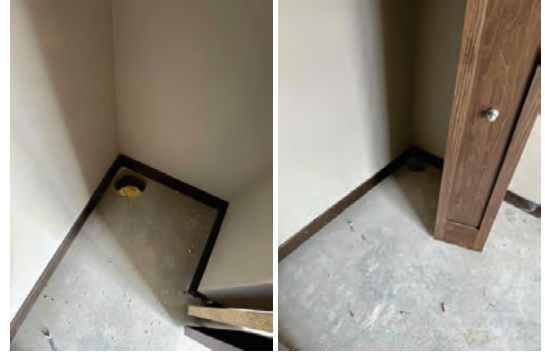
#543: Complete Mech/plumbing trim out

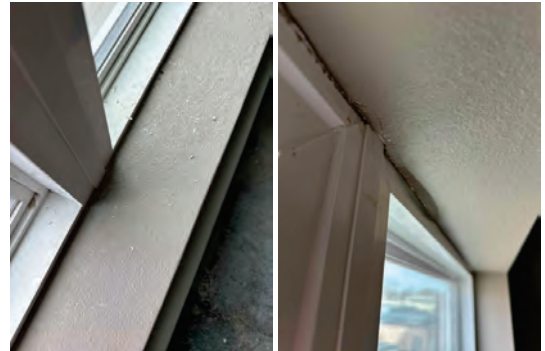
#528: Repair water damaged drywall at living room window

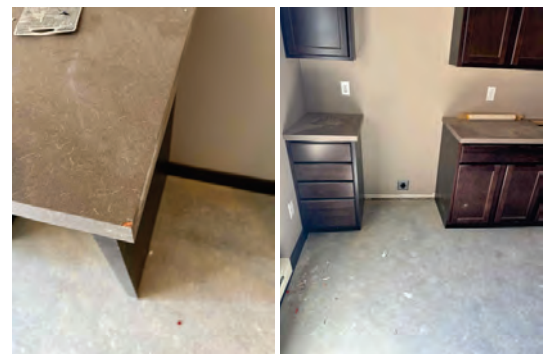
#557: Complete cabinets, countertops, and trim

Type:	Location: 2nd Floor>Unit 206
Date Created: 04/17/2024	Due Date: 04/20/2024
Priority:	Status: Initiated

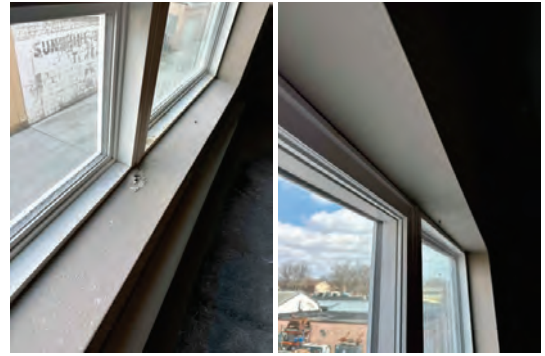
#529: Repair water damaged drywall at living room window

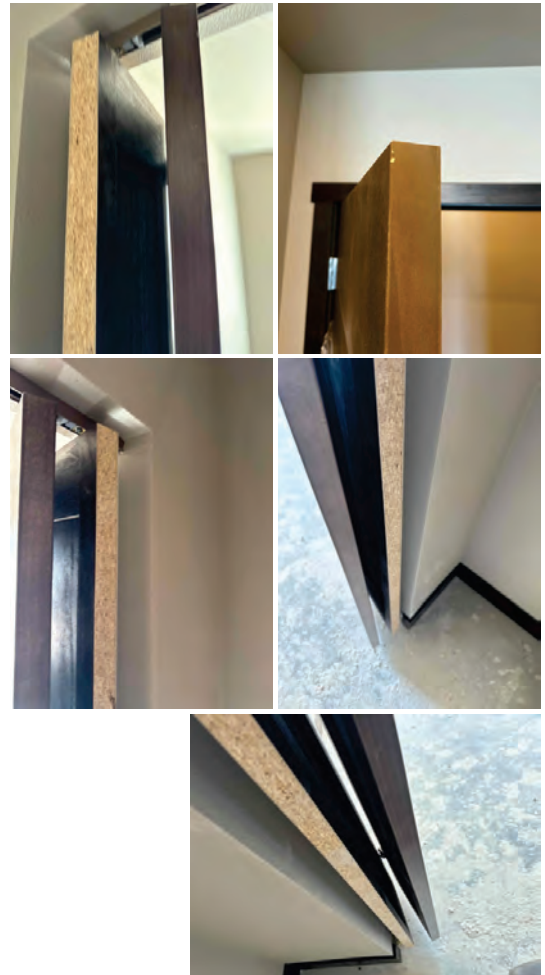
#631: Complete door hardware

Type:	Location: 2nd Floor>Unit 208
Date Created: 04/17/2024	Due Date: 04/20/2024
Priority:	Status: Initiated

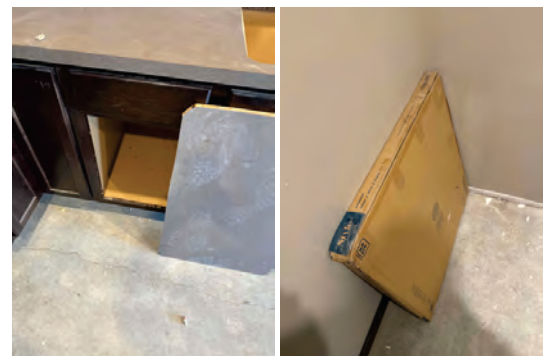
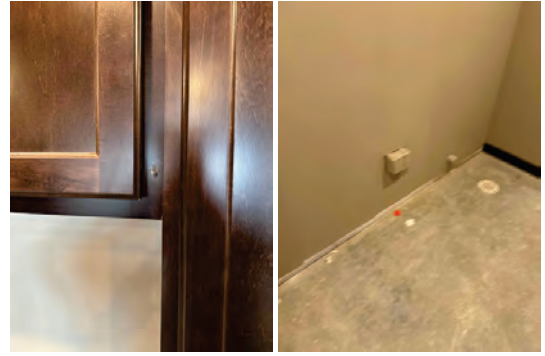
#547: Complete cabinets, countertops, and trim

Type:	Location: 2nd Floor>Unit 209
Date Created: 04/17/2024	Due Date: 04/20/2024
Priority:	Status: Initiated

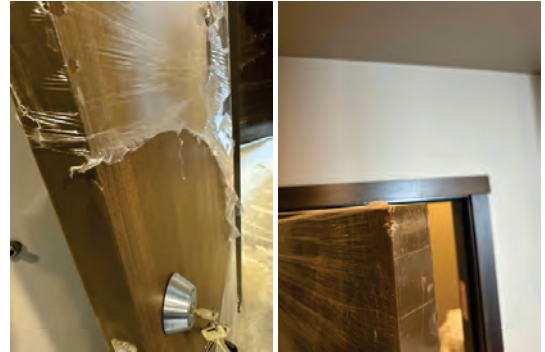
#548: Complete door hardware

Type:	Location: 2nd Floor>Unit 209
Date Created: 04/17/2024	Due Date: 04/20/2024
Priority:	Status: Initiated

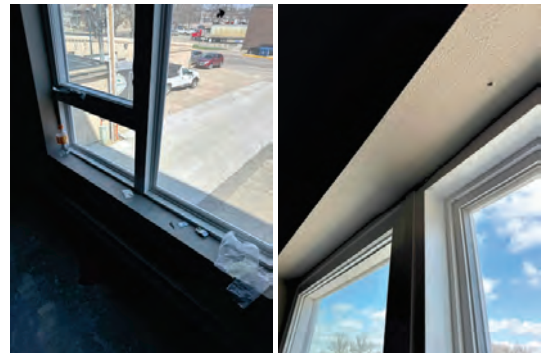
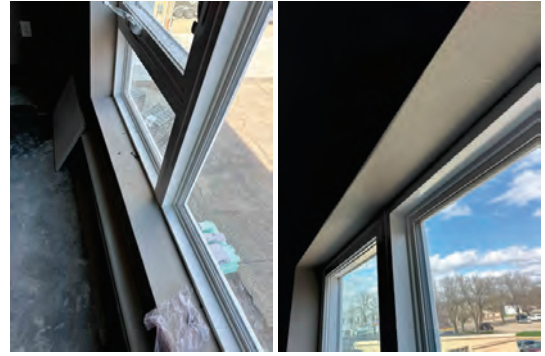
#600: Repair water damaged drywall at both bedroom windows

Type:	Location: 2nd Floor>Unit 213
Date Created: 04/17/2024	Due Date: 04/20/2024
Priority:	Status: Initiated

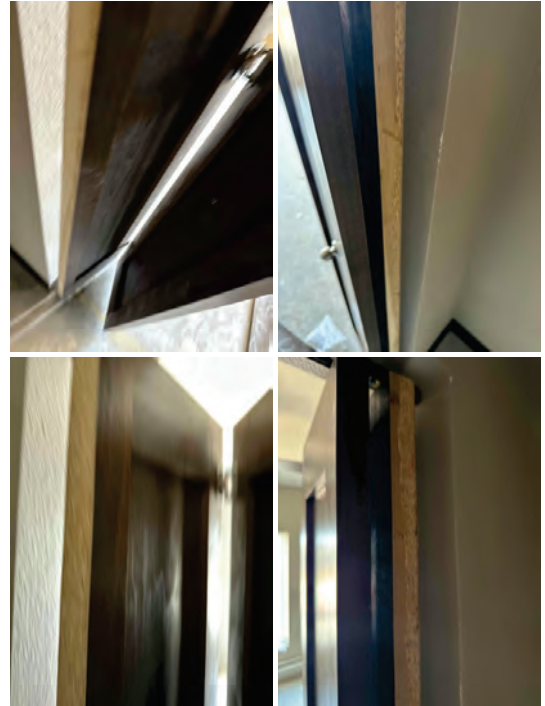
#602: Complete door hardware

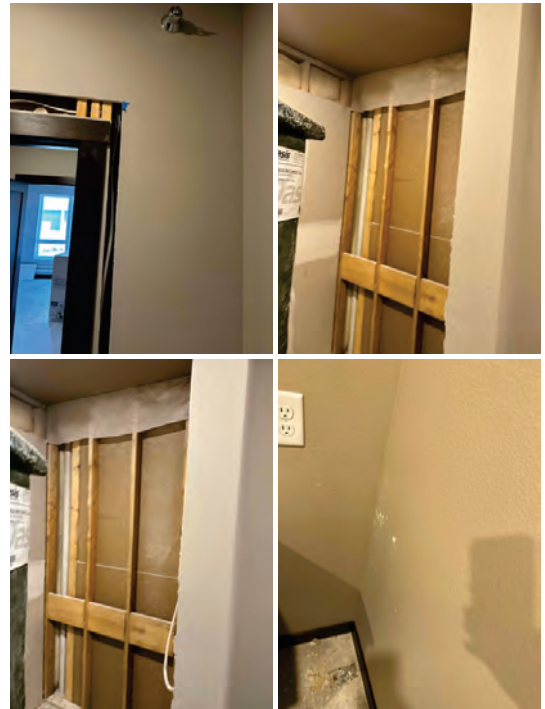
#605: Drywall patch

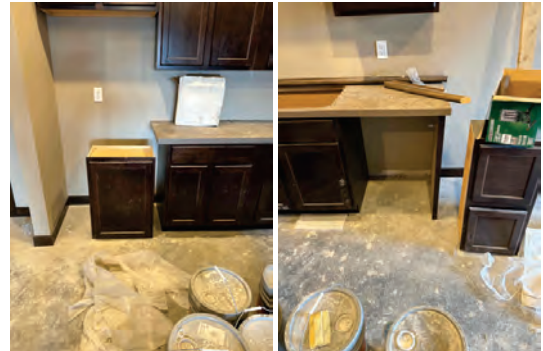
#688: Complete cabinets, countertops, and trim

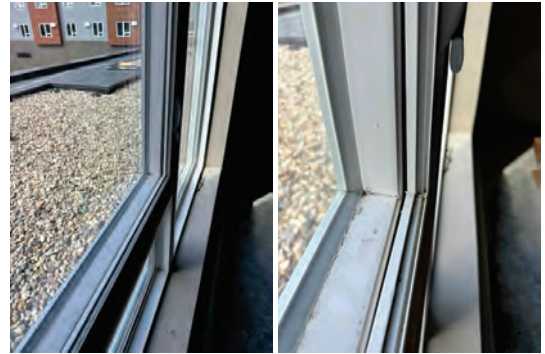
#689: Window operable pane is warped

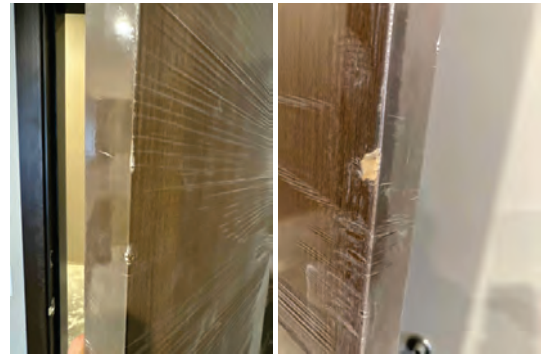
#620: Complete door hardware

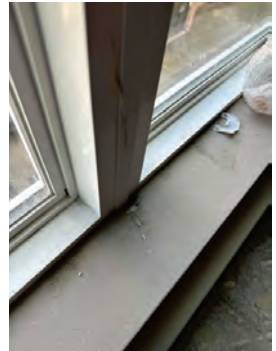
#623: Repair water damaged drywall at bedroom window

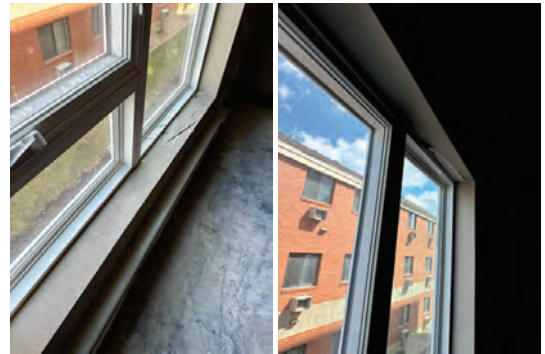
**#639: Repair water damaged drywall at bedroom window**

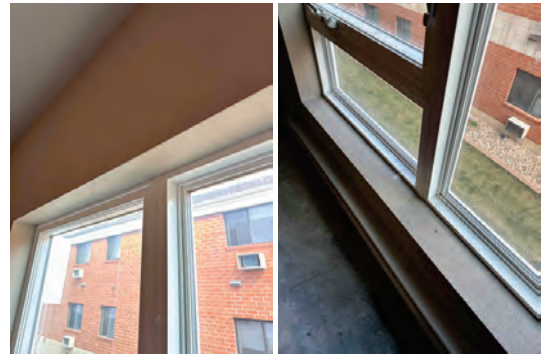
**#680: Repair water damaged drywall at living room window**

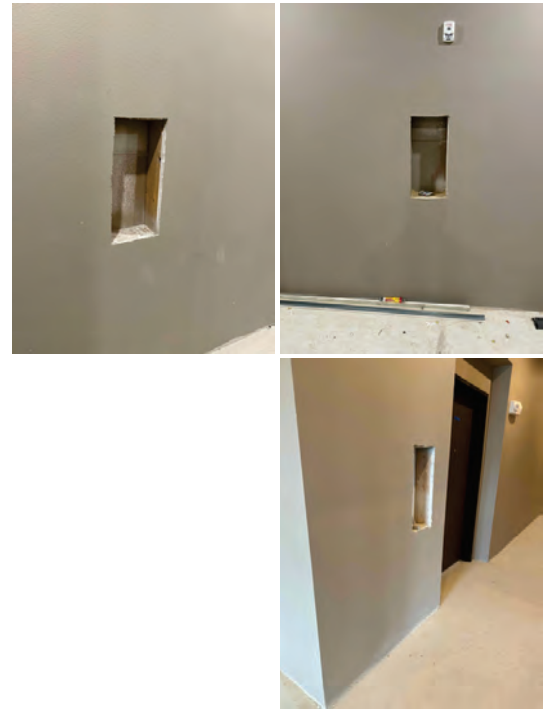
#239: Fire Extinguisher Cabinet Missing - verify RO's meet code

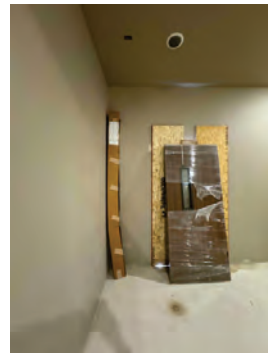
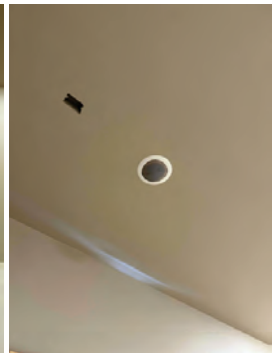
#243: Light fixture full of water - compromised

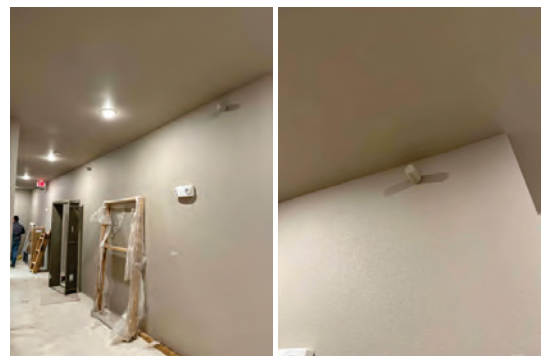
#245: Sprinkler Escutcheons Missing

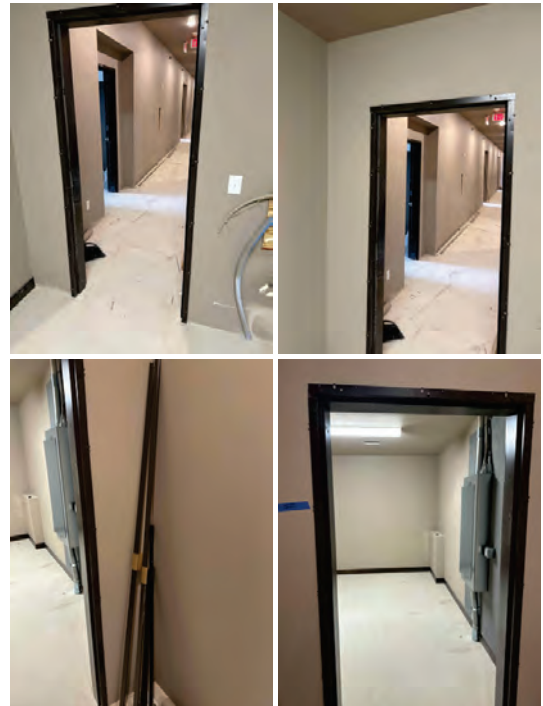
#364: Complete door hardware

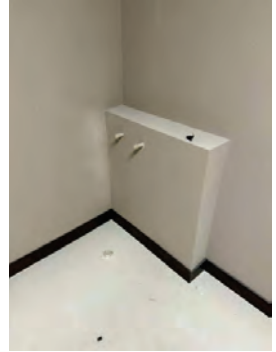
#367: Complete Mech/plumbing trim out

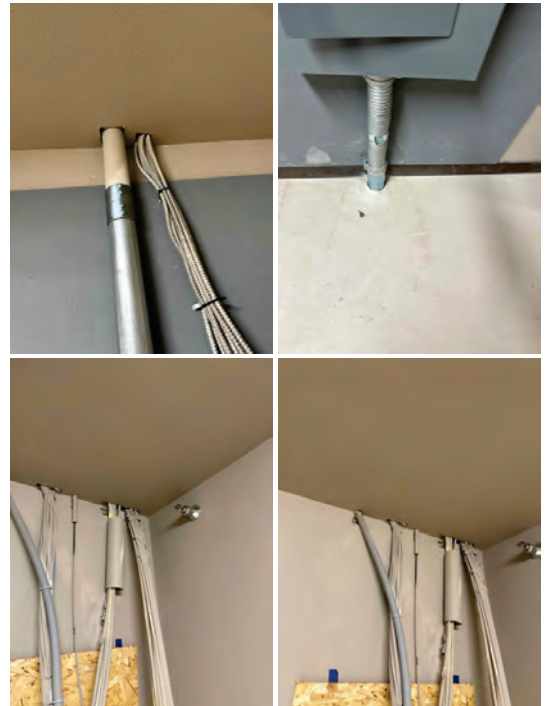
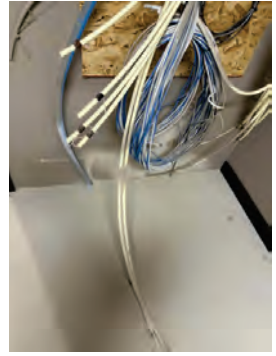
#370: Fire caulk penetrations

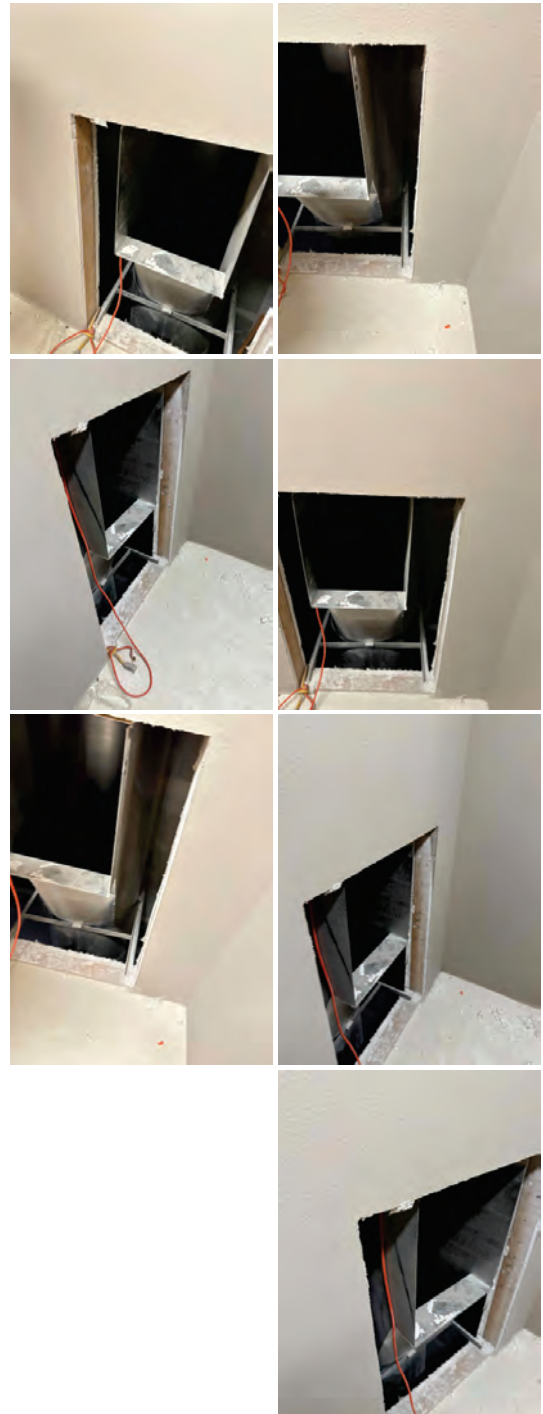
Wall does not meet 2-hour rating

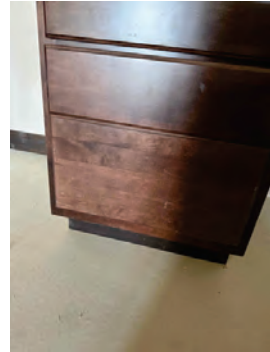
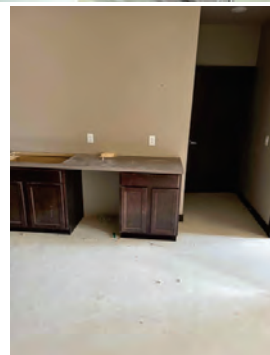
#473: Complete cabinets, countertops, and trim

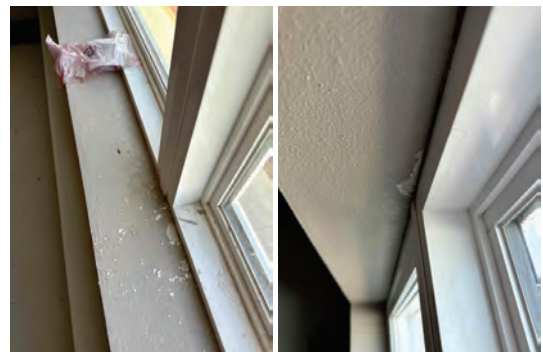
**#460: Repair water damaged drywall at bedroom window**

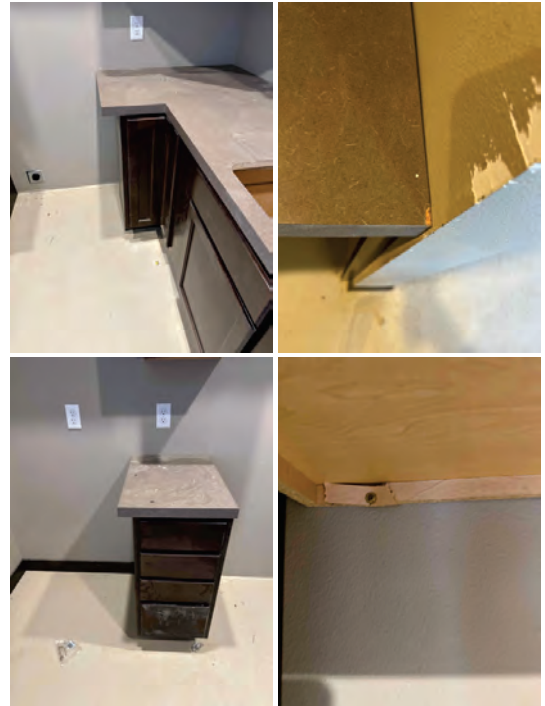
#461: Complete cabinets, countertops, and trim

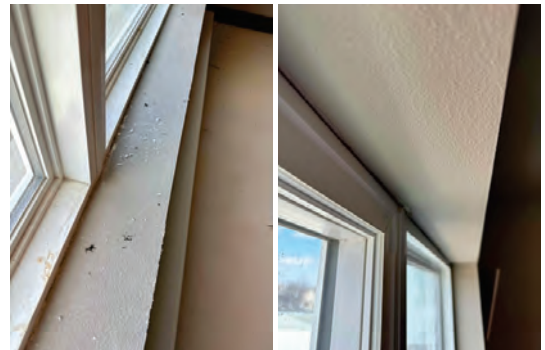
#465: Repair water damaged drywall at living room window

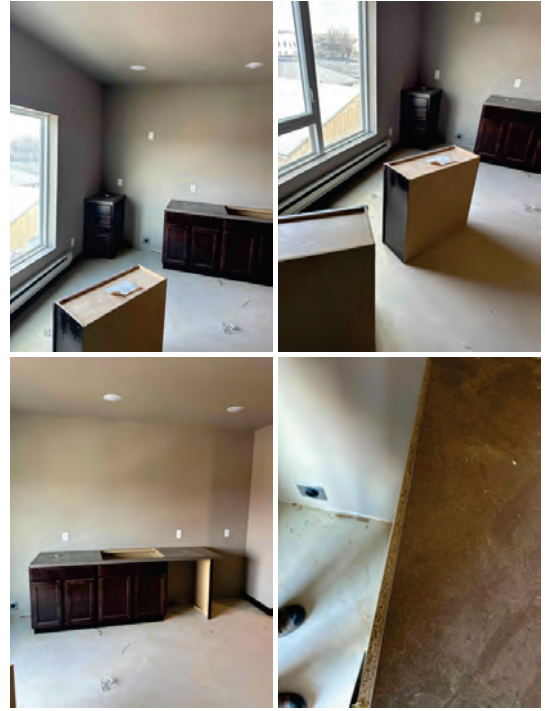
**#450: Complete cabinets, countertops, and trim**
